Presentation on Black Spots under Jurisdiction of NHAI, RO-MUMBAI

Manager (Tech) & RSO, Regional Office, Mumbai

National Highways Authority of India

As on 21.03.2017

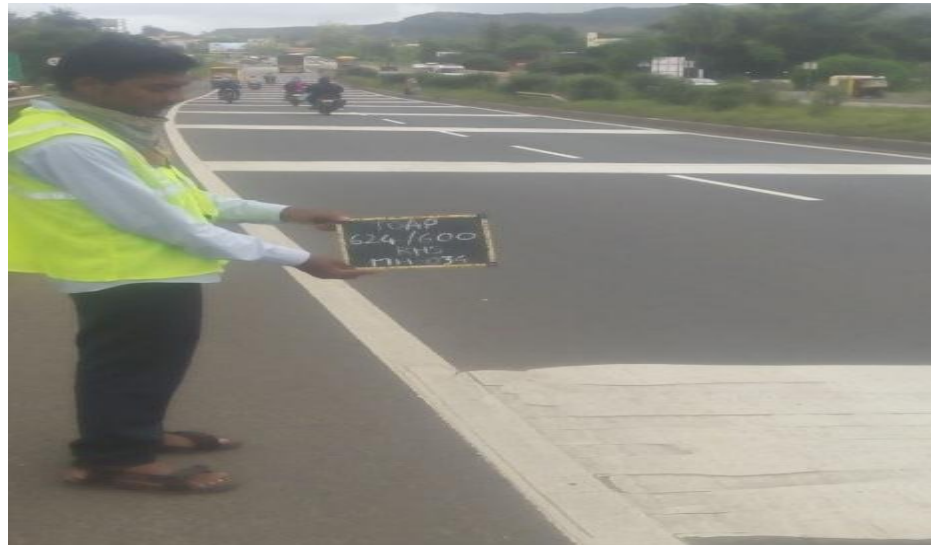
1. Toapgoan to Kasarwadi (Km 624.600) MH-007 on NH-4 Dist. Kolhapur

Reason of Black Spot : T junction and steep slope

Permanent (Long term) measures required: Feasibility report for six laning of Satara - Kagal Section of NH-4 is under finalisation through MSRDC (Present Concessionaire).

Temporary (Short term) measures : Solar Blinkers -3 Nos, Thermoplastic painting, Rumbler Strips, Zebra Crossing, Direction board -2 Nos, Speed Limit boards-2 Nos, Chevron boards -24 Nos, Delinators -21 Nos, Cats Eyes -16 Nos

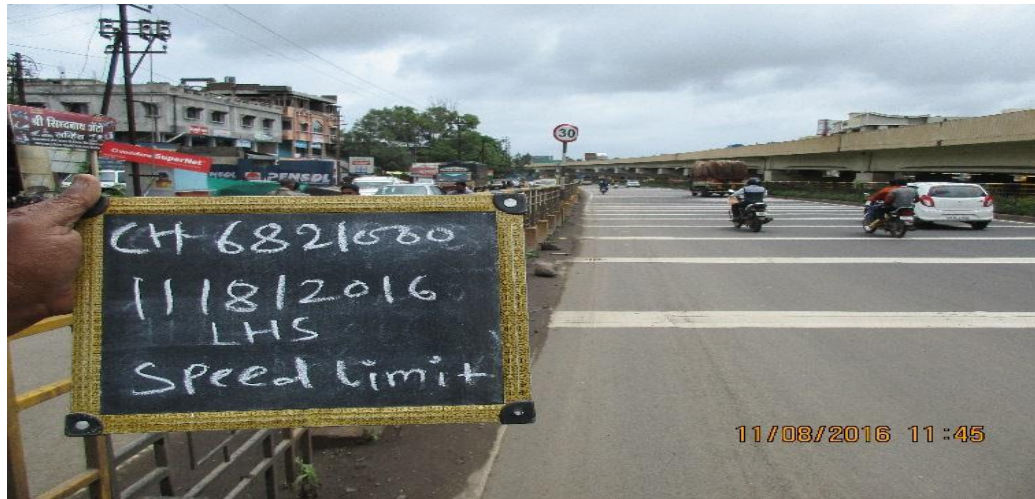
2. Malkapur(Km 680 to 682.400) MH-023 on NH-4 Dist. Satara

Reason of Black Spot : Steep slope & habitation

Permanent (Long term) measures required: Feasibility report for six laning of Satara - Kagal Section of NH-4 is under finalisation through MSRDC (Present Concessionaire).

Temporary (Short term) measures : Blinkers- 2 Nos, Thermoplastic painting/Zebra Crossing, Rumbler Strips, Median Marker

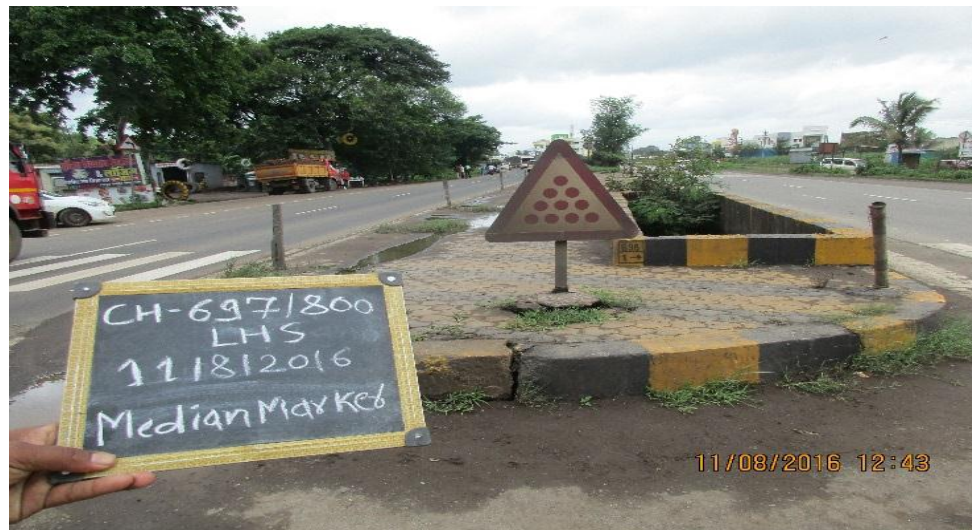
3. Masoor Phata (Km 697.8400) MH-024 on NH-4 Dist. Satara

Reason of Black Spot : T Junction Road

Permanent (Long term) measures required: Feasibility report for six laning of Satara - Kagal Section of NH-4 is under finalisation through MSRDC (Present Concessionaire).

Temporary (Short term) measures: Solar Blinkers -2 Nos Thermoplastic painting -99.72 Sqm, Zebra Crossing - 58.20 Sqm , Rumbler Strips -61.63 Sqm, Direction board - 3 Nos Chevron boards - 13 Nos, Speed limit 50 Board -2 Nos, Hazard Marker Boards - 2 Nos Delinators -19 Nos, Cats Eyes - 50 Nos

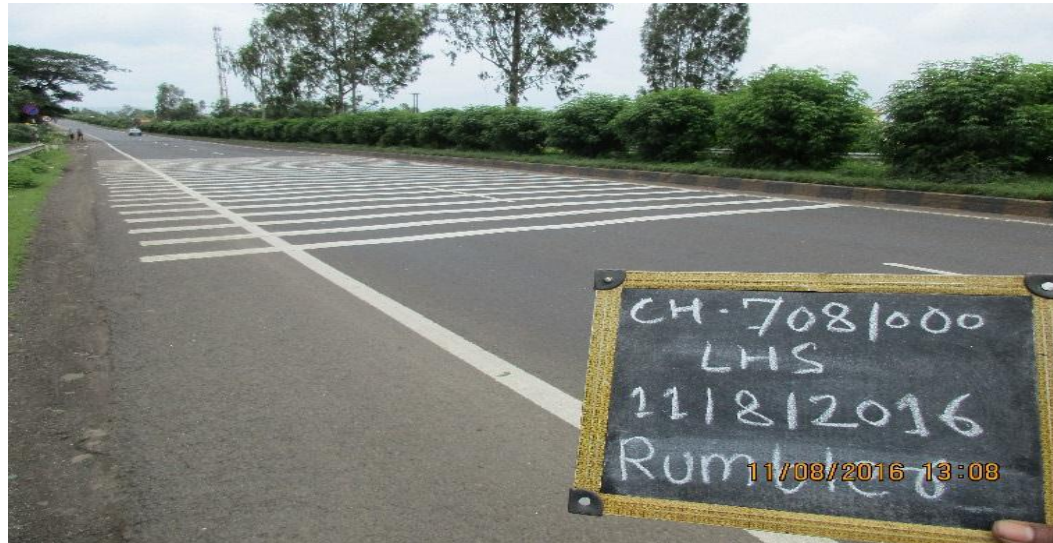
4. Kashil(Km 708) MH-025 on NH-4 Dist. Satara

Reason of Black Spot : Cross pedestrian traffic on steep descend

Permanent (Long term) measures required: Feasibility report for six laning of Satara - Kagal Section of NH-4 is under finalisation through MSRDC (Present Concessionaire).

Temporary (Short term) measures Solar Blinkers -- 2 Nos Thermoplastic painting, Rumbler strips , Cat eyes - 15 Nos, Speed limit 50 Board -2 Nos, Direction Board - 2 Nos

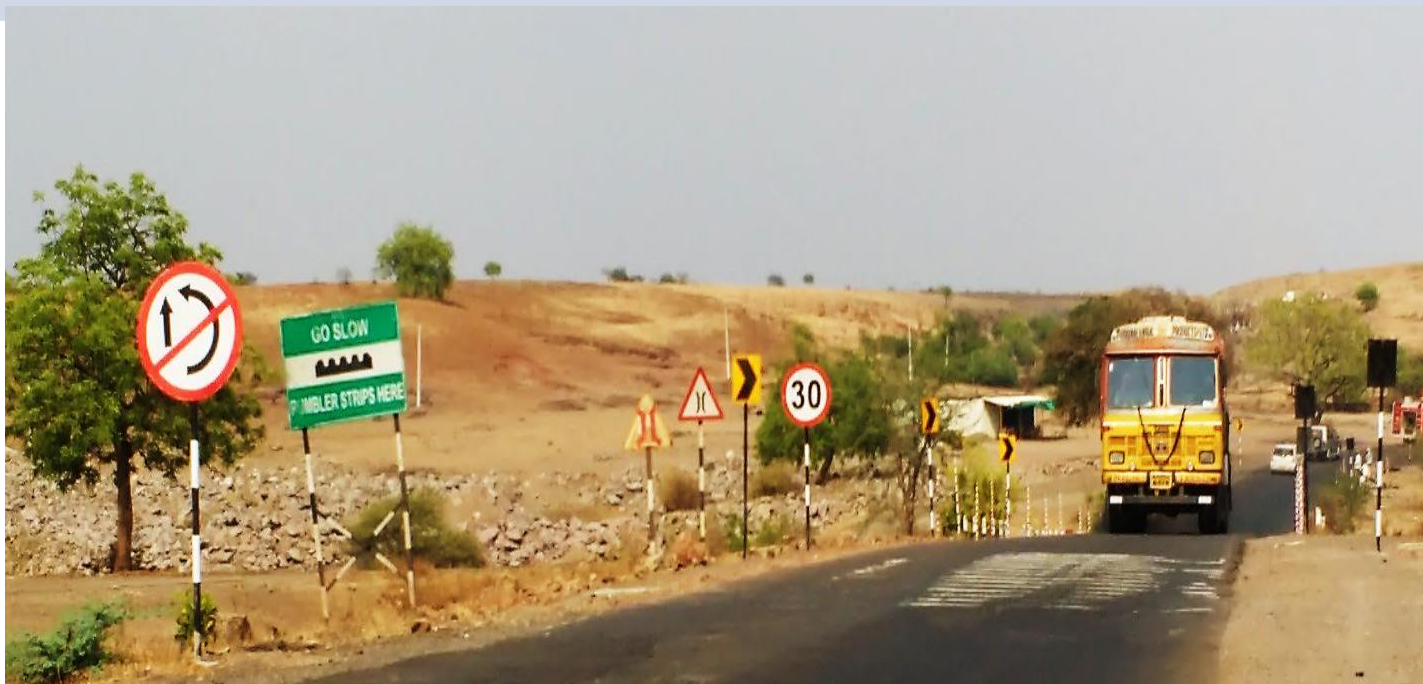
Naldurg Ghat MH 012 on NH-9 Dist. Osmanabad

Reason of Black Spot : Narrow bridge in valley on sharp curve

Permanent (Long term) measures required: Realignment for about 1.5 Km is in progress in 4 laning of Solapur- MH/KNT Border section.

Temporary (Short term) measures:- Rumbler Strips at both sides of locations, 6 nos. At each location and sign boards 2 nos. already provided.

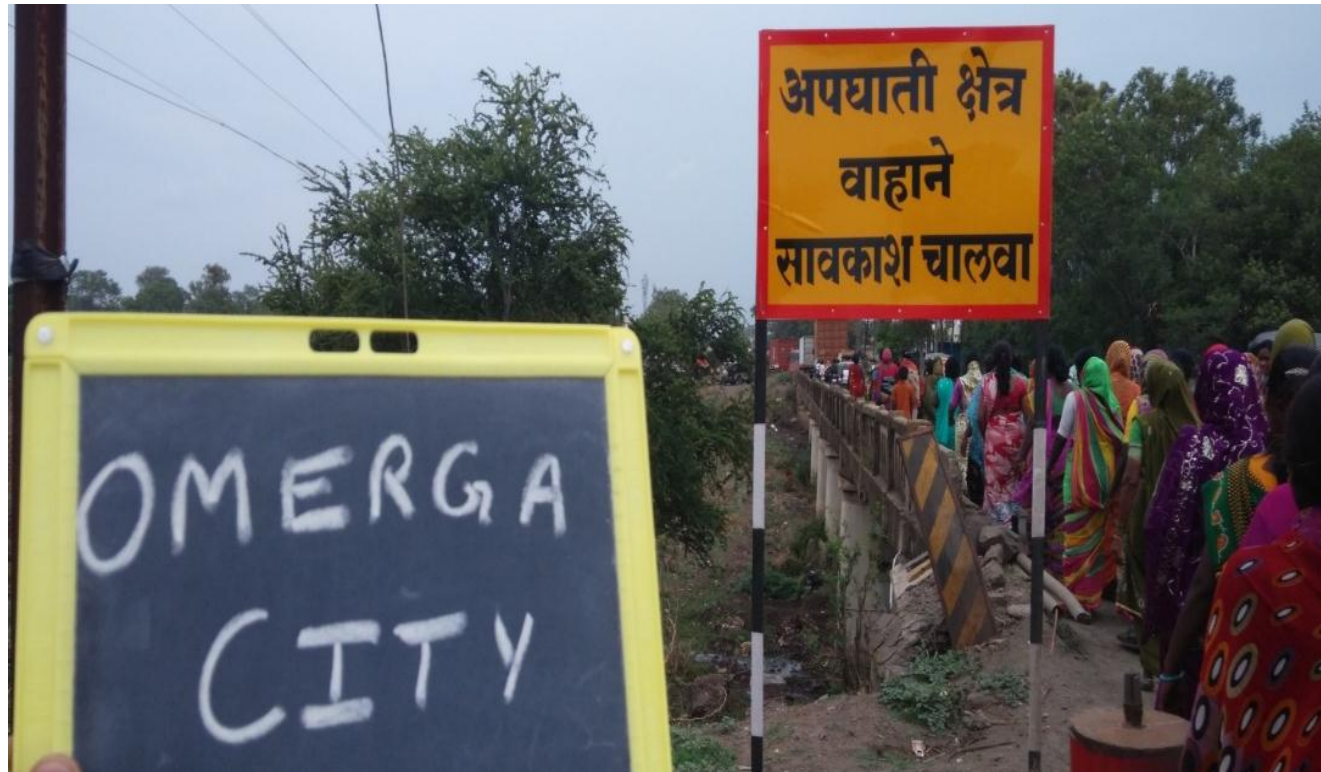
Omerga (Km 328) MH-010 on NH-9 Dist. Osmanabad

Reason of Black Spot : Narrow Bridge in built up/Market area with a cross movement of traffic/pedestrians

Permanent (Long term) measures required: Bypass (6 Km Length) is in progress in 4 laning of Solapur-MH/KNT Border section.

Temporary (Short term) measures:- Proper signage's like go slow, accident prone area have already been provided in this stretch.

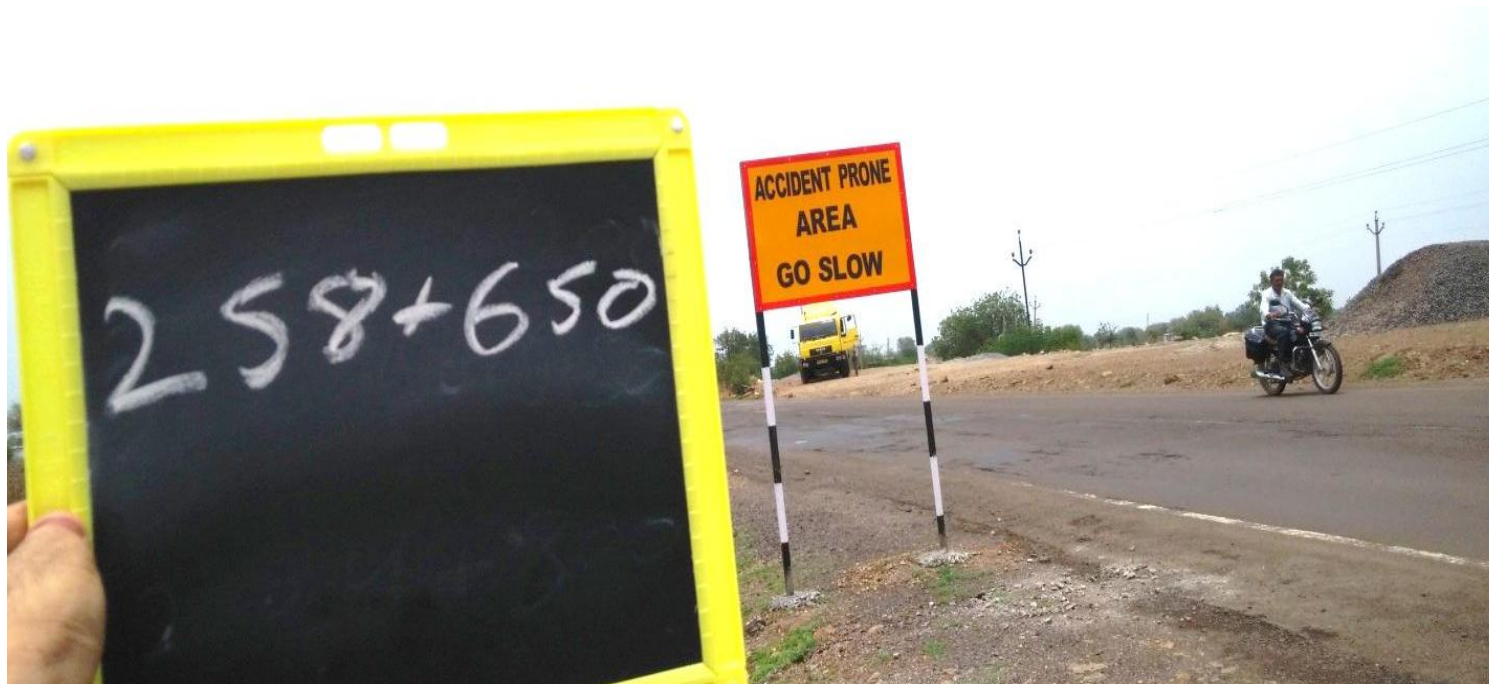
Boramani (Km 258.687) MH-026 on NH-9 Dist. Solapur

Reason of Black Spot : Narrow bridge on curve

Permanent (Long term) measures required: : Adjacent 3 lane bridge is in progress (Cap level) after diversion of traffic existing (2 lane) bridge is to be dismantled to reconstruct 3 lane bridge in 4 laning of Solapur- MH/KNT Border section.

Temporary (Short term) measures:- Rumbler strips on both sides of bridge have been provided along with signages.

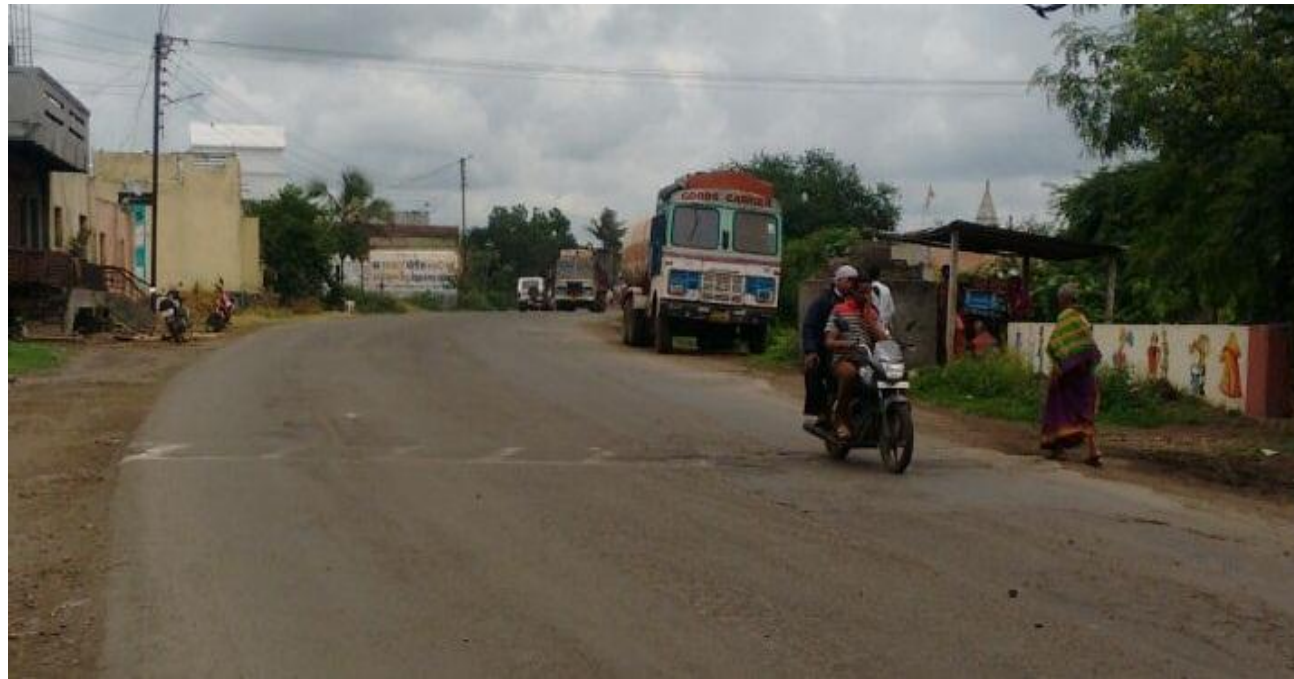
Malumbra (Km 29) MH-013 on NH-211 Dist. Solapur

Reason of Black Spot : Existing Road having Sharp s-type hair pin Curve in Malumbra Village with Narrow Bridge.

Permanent (Long term) measures required: Realignment for @1 Km is in progress in 4 laning of Solapur-Yedshi Section for Mhalumbra village

Temporary (Short term) measures:- Signages for Narrow Bridge & Curve provided, Necessary Rumbler strips have been provided to slow down speed. Existing RCC Damaged Railing has been repaired and temporary wall with safety precaution has been constructed.

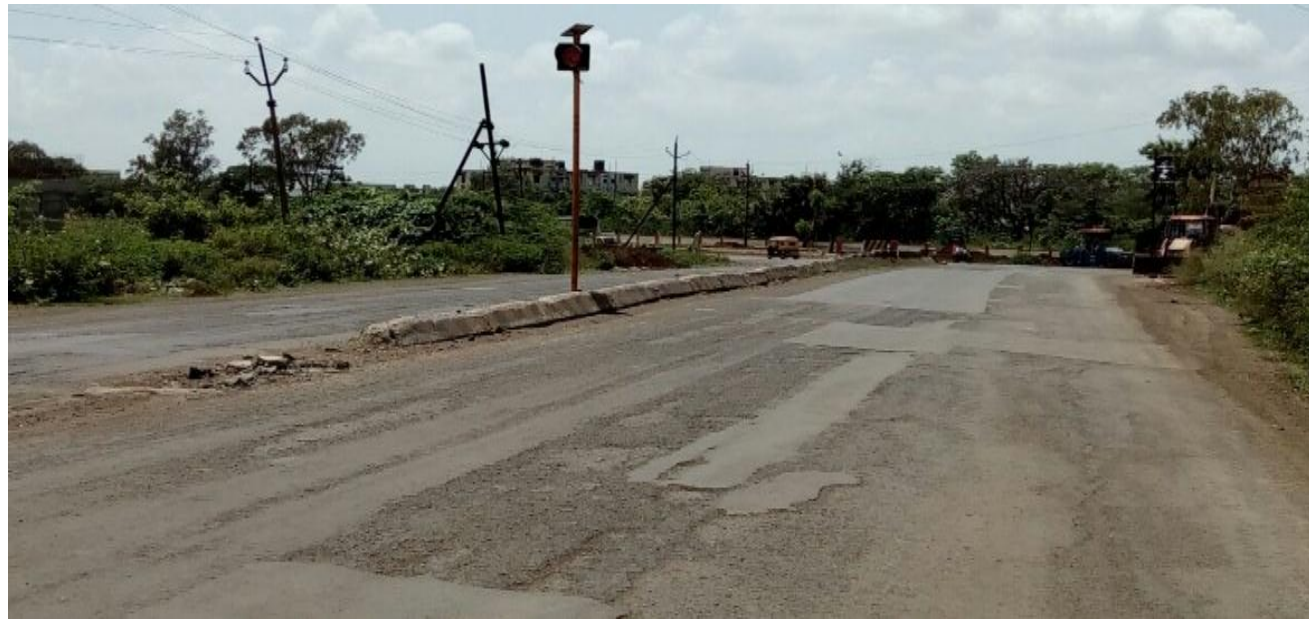
Osmanabad Bypass (Km 60.27) MH-011 on NH-211 Dist. Osmanabad

Reason of Black Spot : Y Junction in Osmanabad City.

Short Term Measures: - All safety measures have been taken by the Concessionaire i.e. Sign boards provided. Necessary speed breakers have been provided to constraint the s

Long Term Measures: - As per Concession Agreement proposed the construction of new VUP at Ch. 58+968 (existing Km. 60+127) is in programme up to superstructure and this may completed by end of November 2016 which will permanently eliminate the said Black Spot. Traffic blinkers provided at both end of this location.

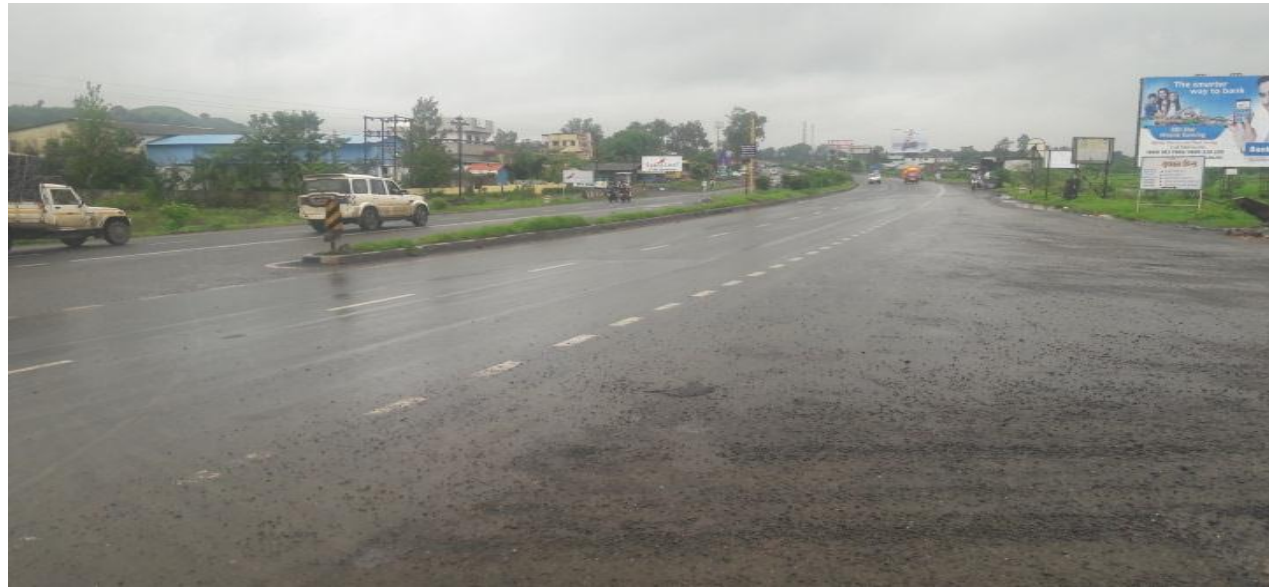
1. Ghoti Sinner Road(Km 453.800) MH-030 on NH-3 Dist. Nashik

Reason of Black Spot : At grade T-Junction, descend on one arm of T-Junction coupled with habitation at junction.

Short Term Measures: - Construction of VUP / Flyover is required. DPR (RFP) for Six laning of the section under Capacity Augmentation is in progress. Expected time to complete the same (VUP/flyover) is December 2018.

a) Road signs, such as median breaks, cluster, Go Slow, speed limit etc. installed. b) Solar Blinkers at junction installed in both directions of the carriageways. c) Cautionary Road Signs installed. d) Road reflective studs installed. e) Thermoplastic Road Marking provided.

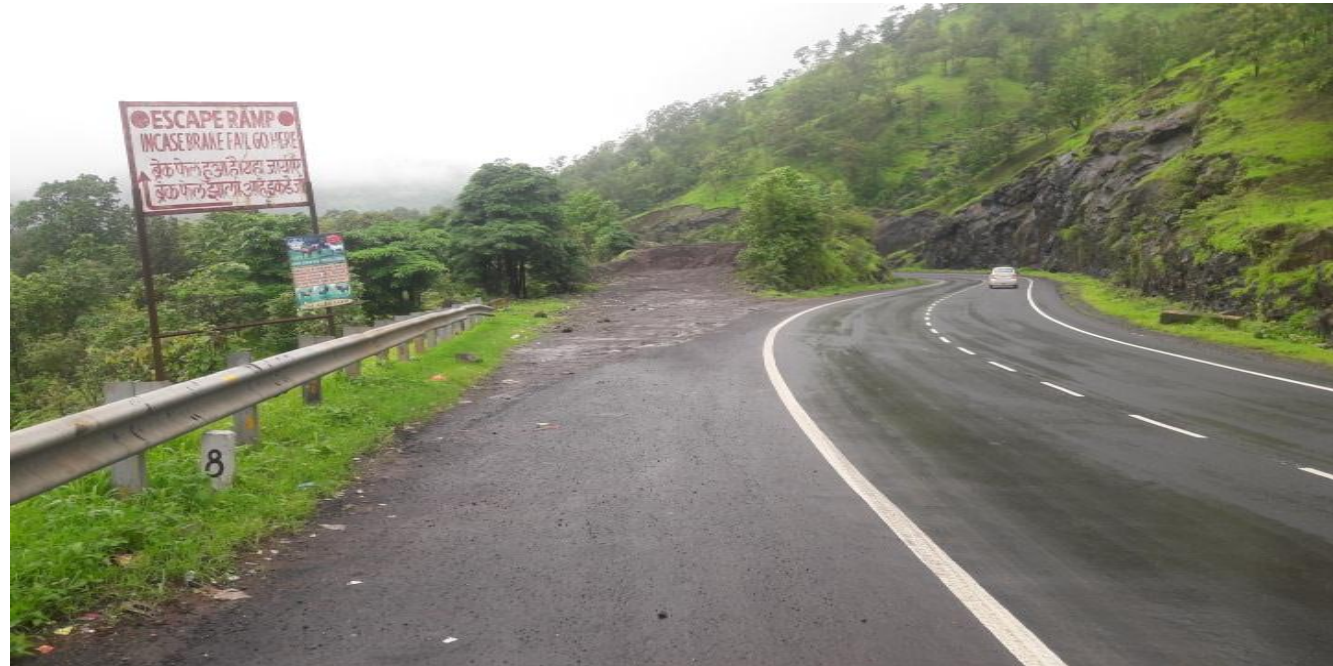
2. New Kasara Ghat (Km 470.500) MH-033 on NH-3 Dist. Thane

Reason of Black Spot : Continuous descend coupled sharp curve in Ghat

Permanent (Long term) measures required: DPR (RFP) for Six lane of Vadape-Gonde section from bidding is under process. Flyover shall be proposed at this location curve shall be improved at this location.

a) Micro surfacing and BC layer provided on the carriageway as part of periodical maintenance. b) Sand bags to act as crash attenuators are provided. c) Installation of Solar Blinkers at Junction for both direction of the carriageways is under progress. d) Road reflective studs installation under progress. e) **Additional Cautionary** Road Signs installed. f) Thermoplastic Road Marking.

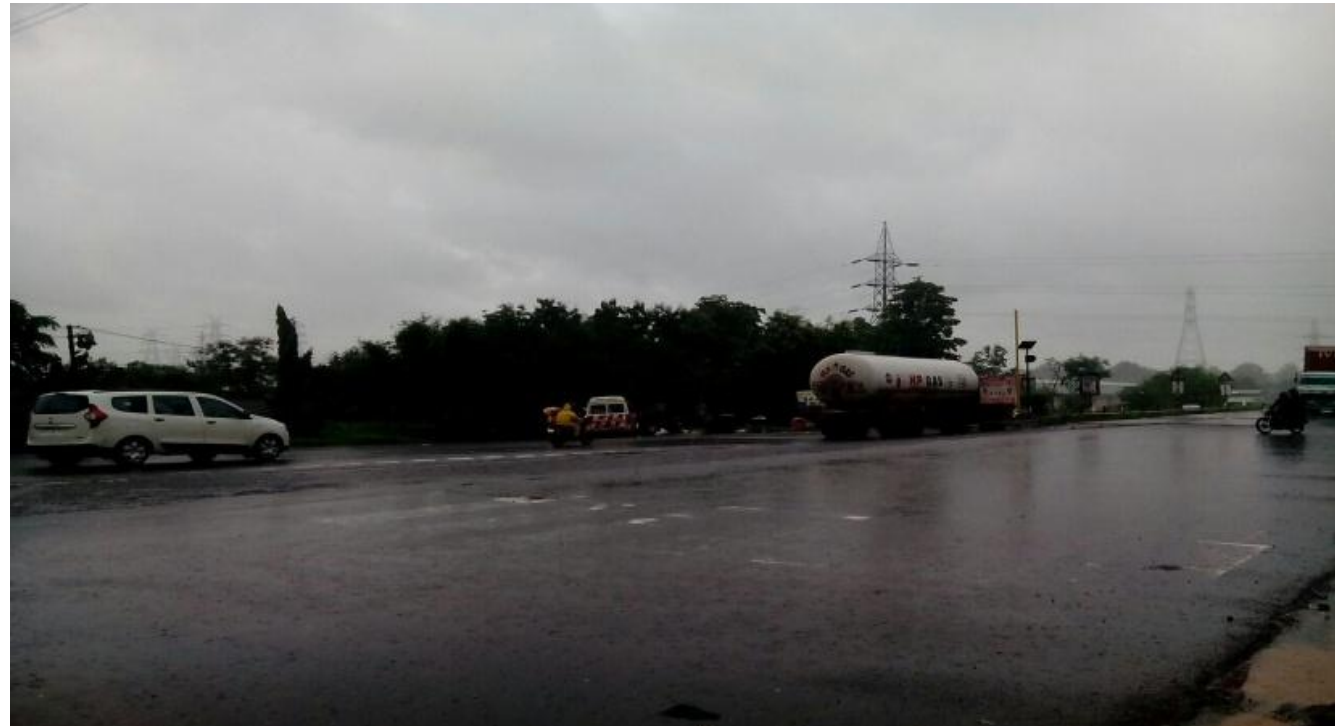
3. Khandavli Junction(Km 528.200) MH-034 on NH-3 Dist. Thane

Reason of Black Spot : At grade T-Junction on High embankment of Major bridge on descending gradient causing acceleration/over speeding.

Permanent (Long term) measures required: COS order issued vide NHAI Lr. No.176, Dtd. 15.04.2014, however, concessionaire didn't take up the work under the pretext of non workable rates. Proposal (with updation of rates) is under process at PIU Nashik level for approval of Competent Authority.

- a) Solar Blinkers Installed at Junction for both direction of the carriageways. b) High mast light provided. c) Cautionary Road Signs provided. d) Road reflective studs. e) Thermoplastic marking.

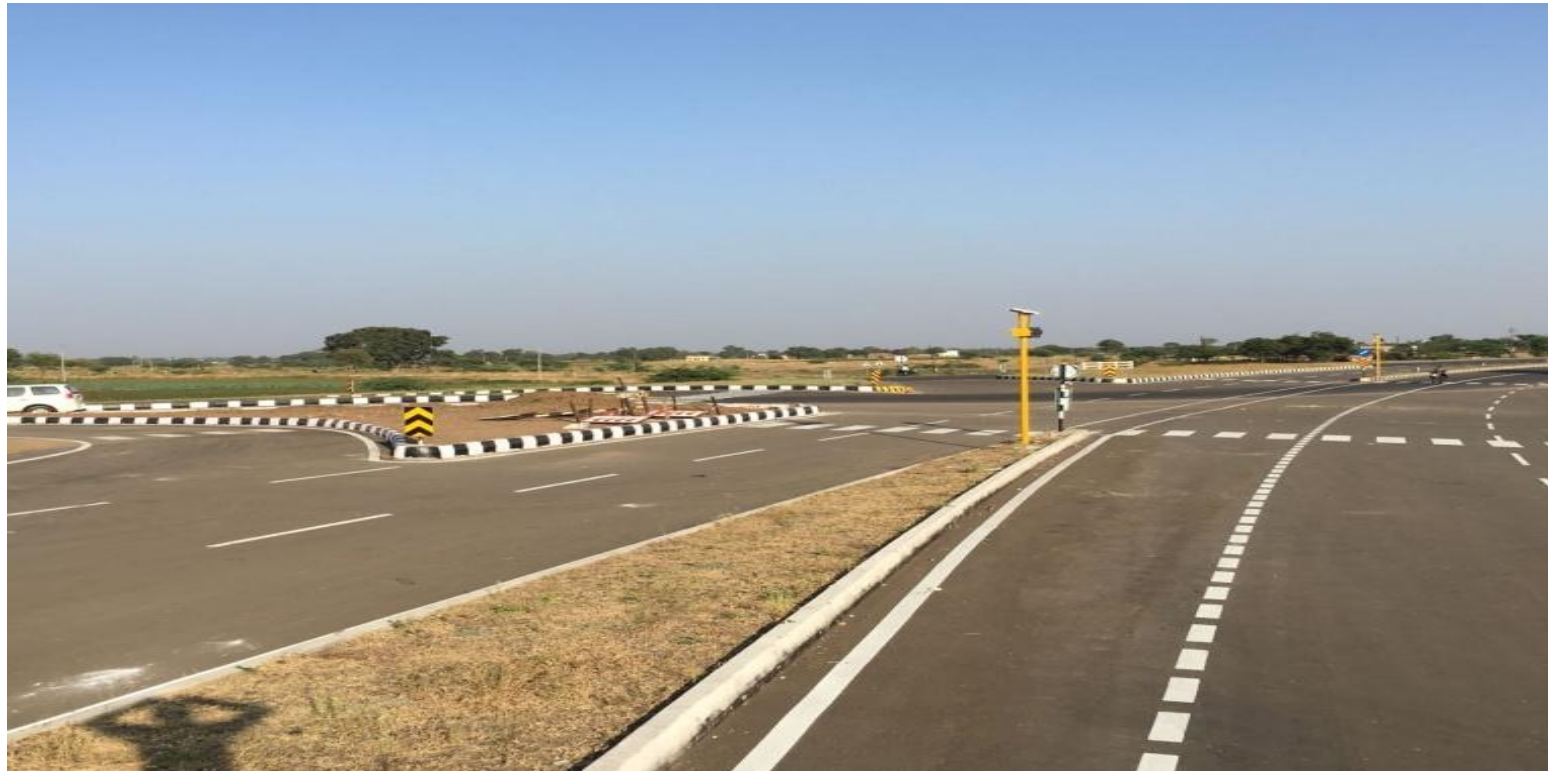
4. Gurewadi Junction(Km 179.800) MH-009 on NH-50 Dist. Nashik

Reason of Black Spot : At – grade X junction on 2 – lane NH with ODR-168 (Manegoan to Musalgon Road) with steeper slope on approach of ODR road as ODR is at low level than NH.

Long-term rectification work(s) completed in Jan 2017 ::

Gurewadi junction has been developed under 4 – lanning of **Khed - Sinnar** section in conformity with IRC specifications & in addition, following safety measures have been provided at junctions.

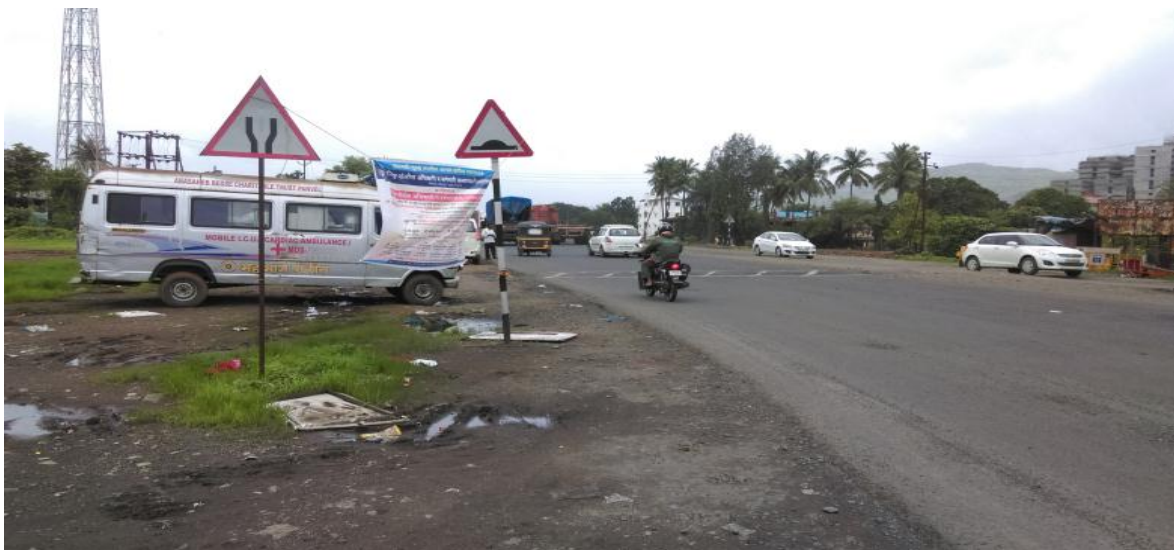
PALASPE (Km 0.250) MH-022 on NH-17/4B Dist. Raigad

Reason of Black Spot : At grade Junction of NH-17 & NH-4B coupled with pedestrian traffic.

Permanent (Long term) measures required: Flyover proposed in Widening to (6/8 lane) of NH-4B & SH -54, JNPT Port connectivity (PKG-IV) Project, work started in May 2016, works is in progress.

Rectification work done/being done : Necessary signs boards & channelizes provided, heavy pot holes repaired, High mast light provided.
